Clara Rockmore RCA Theremin Report

May 31, 2012

On 27 and 28 March, 2012, Andrew Baron and Mike Buffington came to the Musical Instrument Museum (MIM) in Phoenix to study Clara Rockmore’s RCA Theremin (serial number 100006), which was known to have been modified by the instrument’s inventor, Leon Theremin. The purpose of the visit was to establish the extent to which this instrument had been modified, and to conduct dynamic tests under power. A summary of Leon Theremin’s modifications, and what each would have meant to Clara as a performing artist, appears in section 9. A summary of the modified parts of the circuit appears in the Appendices.

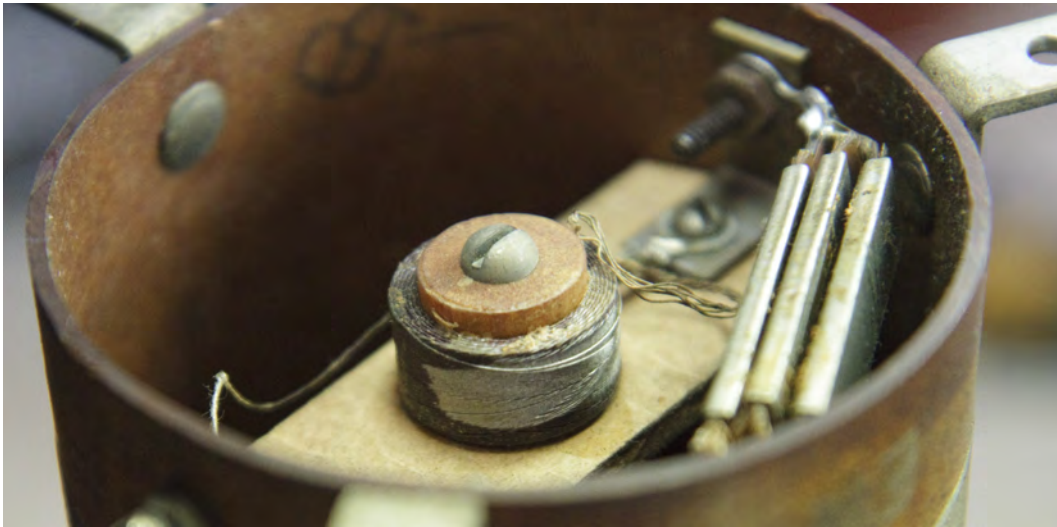
wires and were re-wound by Termen to entirely different specifications based on his own calculations. The concentrated coil and the volume resonant coils were also significantly altered. This involved winding six new coils and removing hundreds of turns of wire from the volume coil and the concentrated coil, within the base of the pitch control resonant coil (PCRC).

Figure 3: Altered concentrated coil located inside the PCRC.

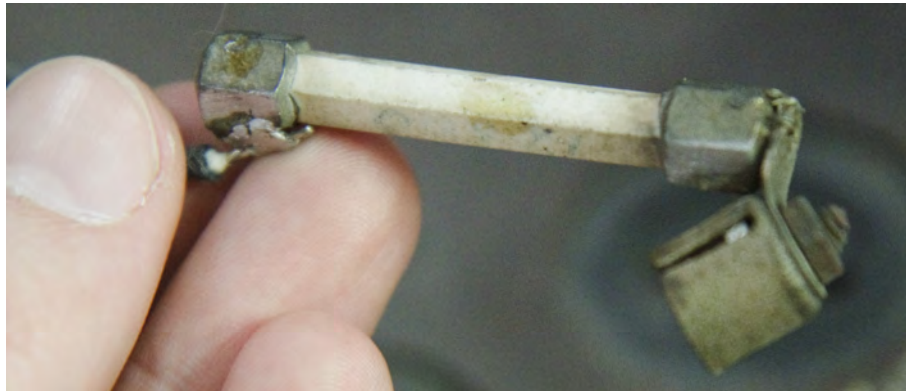
The resistor located at the end of the wire that connects to the top of the 24A mixer tube has an important role in balancing the input of the sine wave from the fixed pitch oscillator, with the input of the sine wave from the variable pitch oscillator. The resistor found at this location was a non-RCA type, and can be assumed to have been hand-selected and installed by Termen.

Careful selection of this resistor will yield the most pleasing tone quality or "voice" of the instrument.

Figure 11: Non-RMA color coded 14,100 Ω resistor.

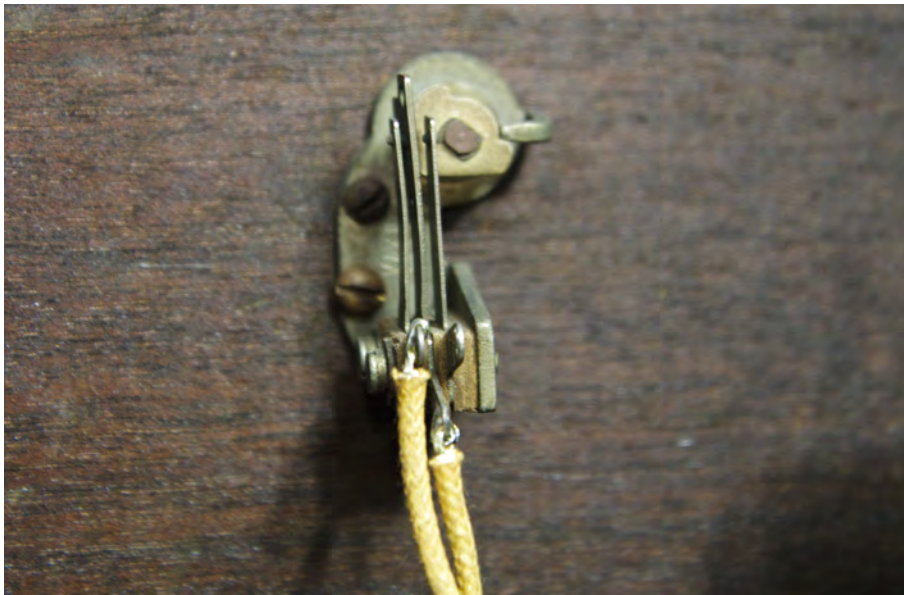
A two-position rotary switch has been added to the vertical front panel of the cabinet, and wired to selectively shunt or disconnect a 0.12 μF capacitor across the speaker pin jacks of the Socket Power Unit.

Figure 12: This two-position rotary tone switch was added by Termen.

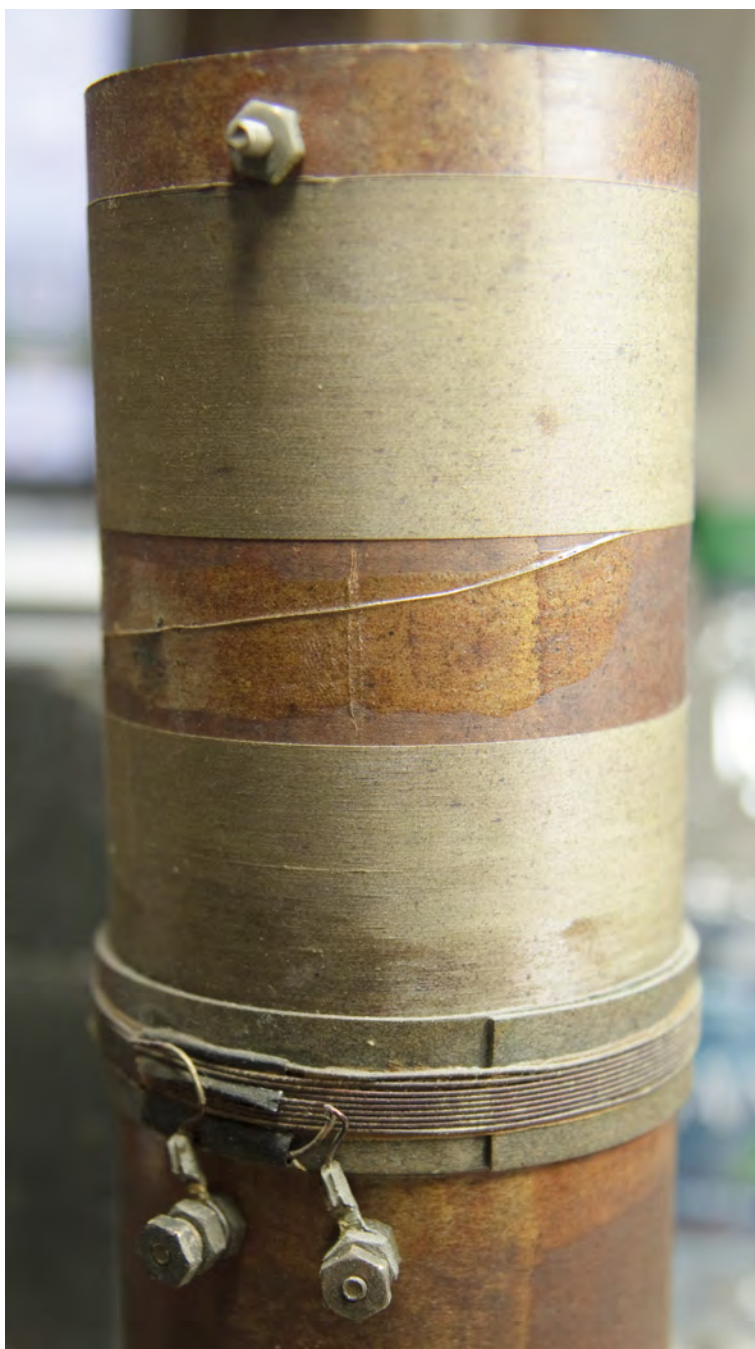
We believe the alterations to the volume oscillator operating frequency were made to maximize the sensitivity of the volume circuit.

Figure 13: Volume coil with center windings removed and ends joined.
