RCA Theremin

SERVICE NOTES

First Edition—5M
Copyright November 1929

RADIO-VICTOR CORPORATION OF AMERICA 233 BROADWAY, NEW YORK CITY

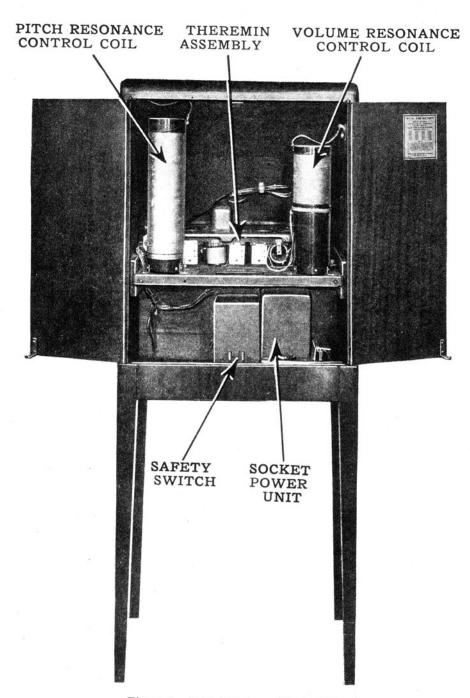
Figure 1-Rear interior cabinet view

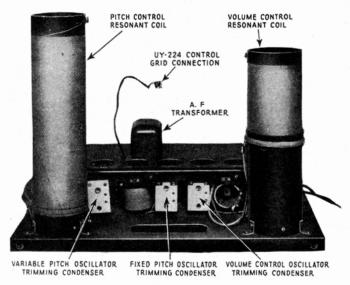
Figure 2—Top chassis view of the main assembly

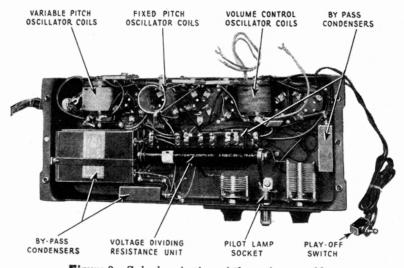
Figure 3-Sub-chassis view of the main assembly

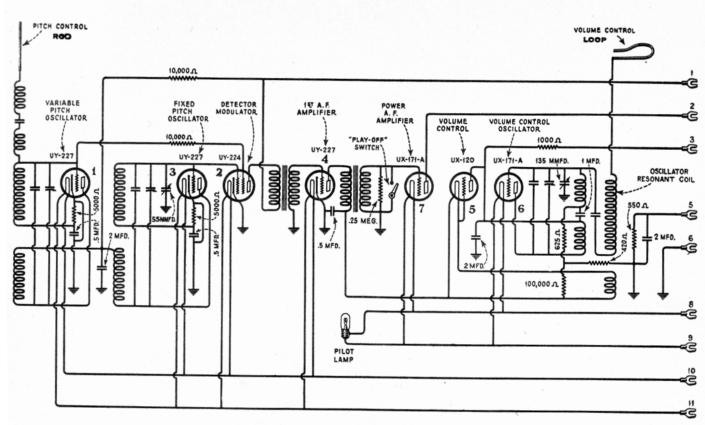
Figure 4—Schematic circuit diagram of the main assembly

Referring to the schematic circuit Figures 4 and 5 and starting from the pitch control rod we find the circuits functioning as follows:—

The pitch control rod is connected to a coil having a very high inductance. Connected to this coil is a small condenser and a small concentrated coil. This entire circuit is tuned by the distributed capacity of its coils and resonates at approximately 172 K.C. Not having any fixed capacitor connected across it for tuning, the ratio of inductance to capacitance is very high. Thus the small increase of capacity caused by the hand close to the pitch rod will cause the circuit to change its natural period considerably, a great deal more than if a large capacity and small inductance were used.

This pitch control circuit is connected to the grid side of the variable pitch control oscillator the frequency of which is slightly greater than that of the pitch control circuit. Bringing the hand close to the pitch rod will increase the parallel capacity in that circuit and thus reduce its frequency. As this capacity is reflected in the oscillator circuit a similar decrease in frequency will result in that circuit, the amount of decrease depending on the closeness of the frequency of the two circuits. Thus a greater decrease in frequency of the oscillator circuit is obtained when the pitch control circuit is close to the oscillator circuit in frequency than when it is at a greater frequency difference.

Examining the circuit diagram we find that each oscillator grid is connected to the control and screen grid respectively of a Radiotron UY-224. As the screen grid has the largest area, a 10,000-ohm resistance is connected in series with it to balance the input to this tube and have each oscillator have the same effect on the detector action. This tube is a detector or combining tube that functions much in the same

The remaining two tubes, Radiotron UX-120 and UX-171A together with the first audio frequency amplifier constitute the volume control system. Examining the UX-171A we find that it is in an oscillating circuit that oscillates at about 420 K.C. Connected to the grid side of the oscillator is the volume control loop circuit. This circuit resonates at a frequency below the oscillator frequency when the hand is entirely removed from the volume control loop. This is done for two reasons. If the two circuits were in exact resonance, the load on the oscillator would be too great and operation would be unstable. Also the pick-up current would be high and might damage the tube. The ratio of inductance to capacity in this circuit is also quite high. A small pick-up coil is wound around the inductance coil of the volume control loop circuit and when both circuits are nearly in resonance (hand entirely removed) sufficient radio frequency current flows in this pick-up coil to light the filament of the Radiotron UX-120 to which it is connected. If the plate supply circuit to the Radiotron UY-227, that is the first audio frequency amplifier, is examined we see that the current for this tube is fed through the UX-120. Thus if the UX-120 were at maximum brilliancy, maximum
